# **EXHIBIT No. 5**

ARCCA, INCORPORATED  
146 N CANAL STREET, SUITE 300  
SEATTLE, WA 98103  
PHONE 877-942-7222 FAX 206-547-0759  
www.arcca.com

Re: *Quinn, Dennis v. Marie Ronkar*  
ARCCA Case No.: 3691-015

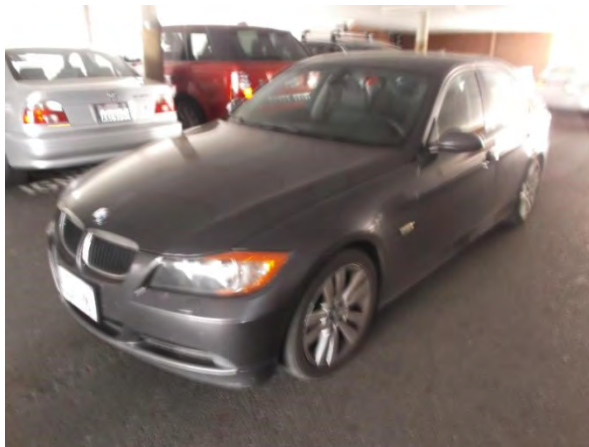
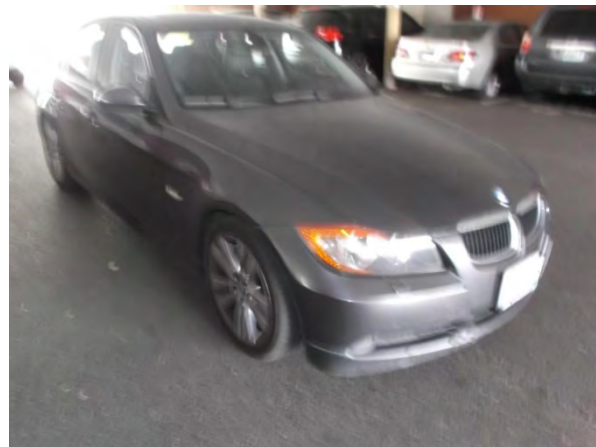
**Figure 2: Reproductions of photographs of the incident 2006 BMW 325i**

The photographs for the incident 2006 BMW 325i depicted no residual crush or signs of structural damage (Figure 2). The front bumper was well aligned with the head lights, grille, hood, and front fenders. There were minor chips and paint scratches to the right side of the front bumper cover.

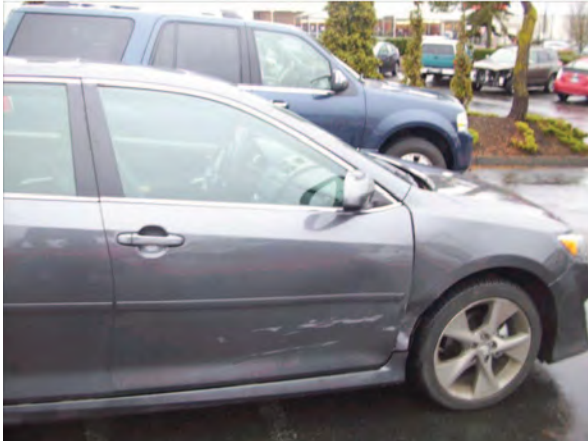
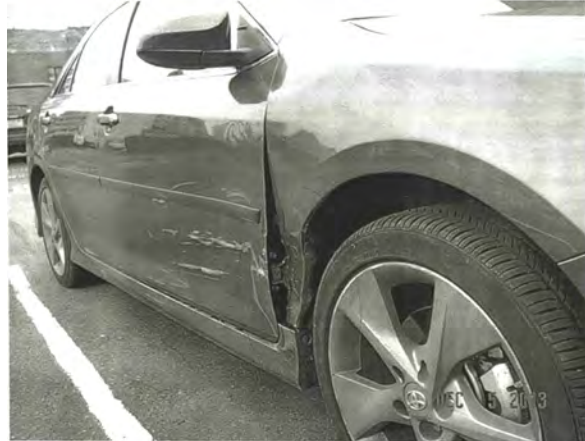
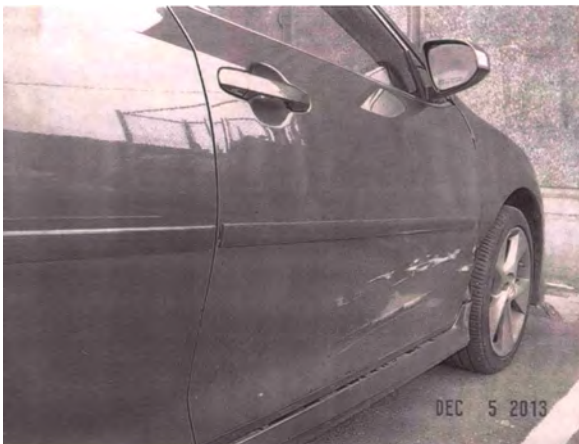
**Figure 1: Reproductions of photographs of the subject 2013 Toyota Camry**

The repair estimate for the subject Toyota Camry reported damage to the right fender, right door shell, upper hinge of the front right door, right quarter panel, and right hinge pillar, which is consistent with the photographs (Figure 1). The reviewed photographs of the subject Toyota depicted horizontal scrapes from the rear portion of the right front fender to just rear of the front right door shell. The rear portion of the right fender was crushed, as well as the front portion of the right front door shell just behind the leading edge of the door.

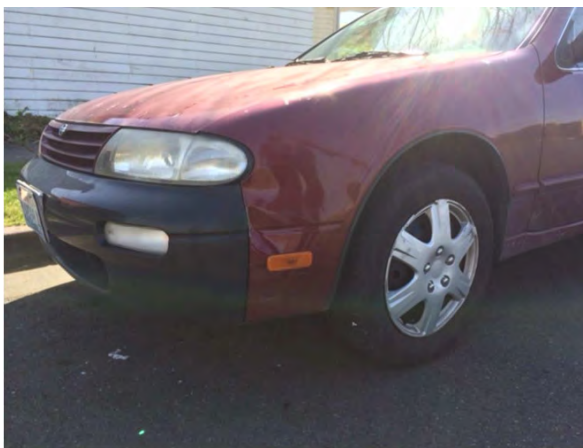
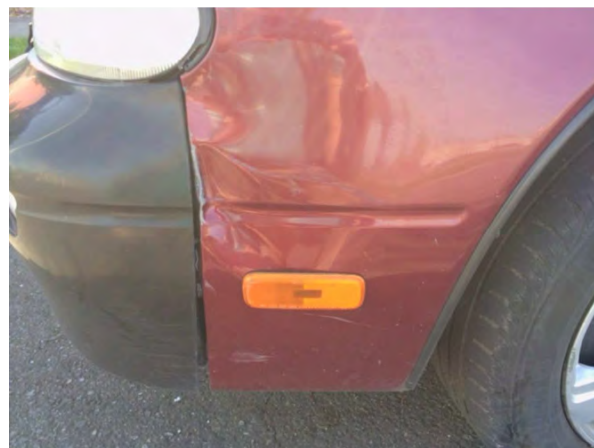
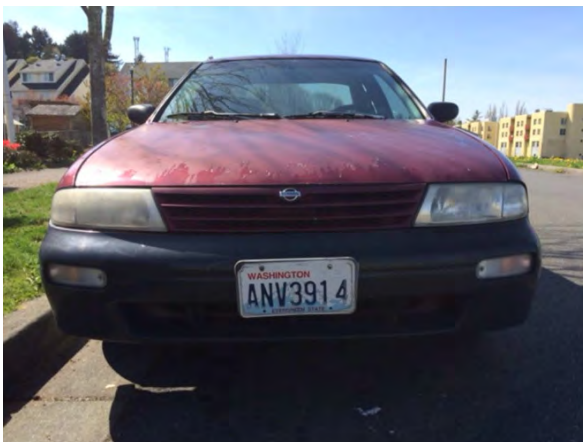
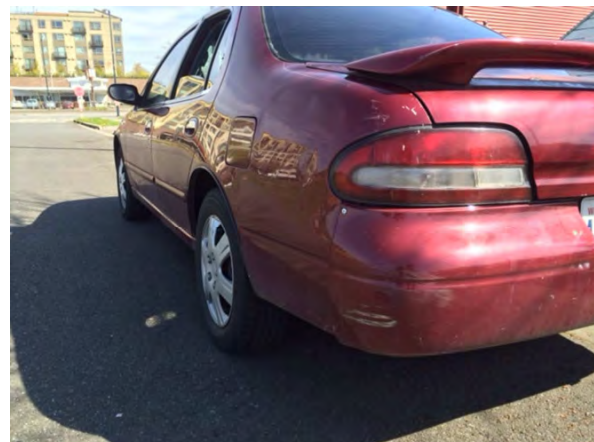
**Figure 2: Reproductions of photographs of the incident 1997 Nissan Altima**

The photographic reproductions for the incident Nissan Altima depicted damage to the front left fender (Figure 2). The front left fender was crushed just above the reflector to the height of the headlight. There were paint chips, scratches, and discolorations throughout the rear of the Nissan, including a horizontal scrape to the left rear bumper cover. However, the State of Washington Police Traffic Collision Report and other available documents indicate that only the front crush was related to the subject incident.

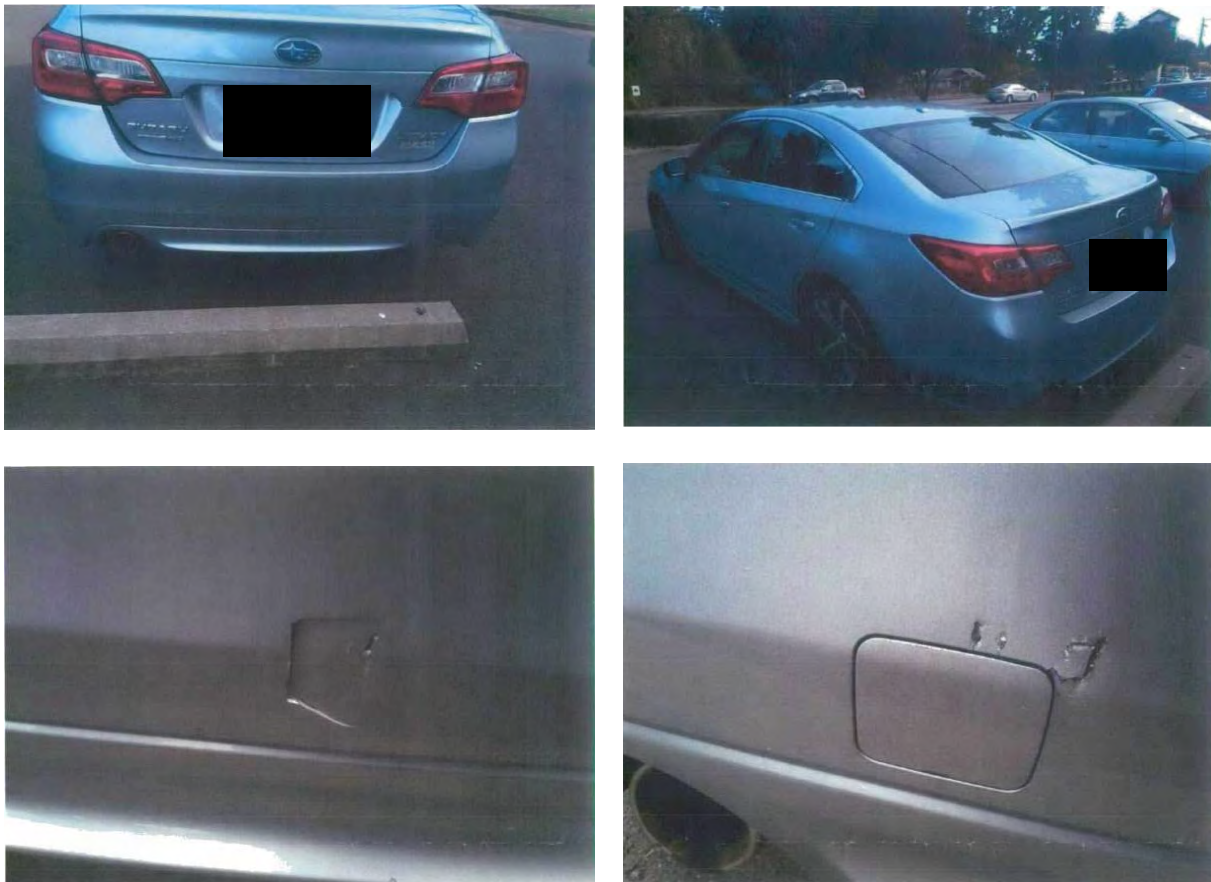
**Figure 1: Reproductions of photographs of the subject 2015 Subaru Legacy**

The repair documents for the subject Subaru reported damage primarily to the rear bumper cover, reinforcement, and the dealer accessory clear mylar due to the subject incident. The reviewed photographs of the subject Subaru were consistent with the repair estimate; the photographs depicted damage primarily to the rear bumper cover (Figure 1). The rear bumper cover damage included a few gouge marks above the left exhaust pipe and a puncture through the bumper cover. Overall, the photographs did not depict significant crush or misalignment of components to the rear of the Subaru.

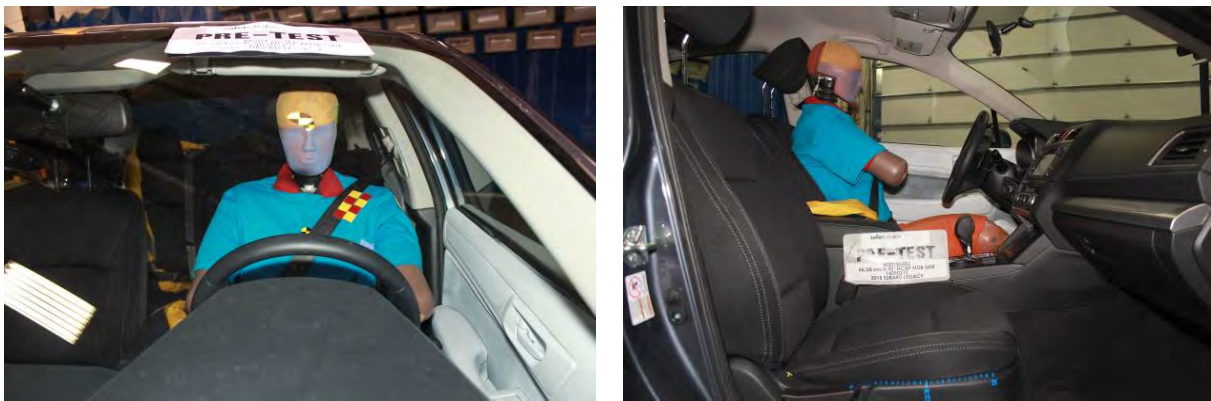
**Figure 2: 50<sup>th</sup> Percentile Male Anthropomorphic Test Device in a 2015 Subaru Legacy**

The primary mechanism for this type of biomechanical failure occurs when the head hyperextends over the headrest of the seat. In a rear impact that produces motion of the subject vehicle, the Subaru Legacy would be pushed forward and [REDACTED] would have moved rearward relative to the vehicle, until her motion was stopped by the seatback and seat bottom. The National Highway Traffic Safety Administration (NHTSA) impact safety tests for continued performance and safety monitoring of the automotive industry. Tests for a 2015 Subaru Legacy showed the seated height of a 50<sup>th</sup> percentile male in the driver's seat was well protected and supported by the head restraint (Figure 2).<sup>31</sup>

Performing an anthropometric regression of [REDACTED] revealed she would have a normal seated height of 34.1 inches, over half an inch shorter than a 50<sup>th</sup> percentile male. Of note, in the above photographs the head restraint is in the full up position however, even in the full down position as noted in [REDACTED] medical records, her head and cervical spine would be well supported. Thus, the seatback and headrest support and the low vehicle accelerations during the subject incident designate that [REDACTED] cervical spine would have undergone only a subtle degree of the characteristic response phases.<sup>32</sup> The load would have been applied predominantly horizontal to her cervical spine and minimized relevant cervical loads.<sup>33</sup> The cervical loads were within physiologic limits and [REDACTED] would not have been exposed to a cervical spine biomechanical failure mechanism during the subject incident.<sup>34,35,36</sup>

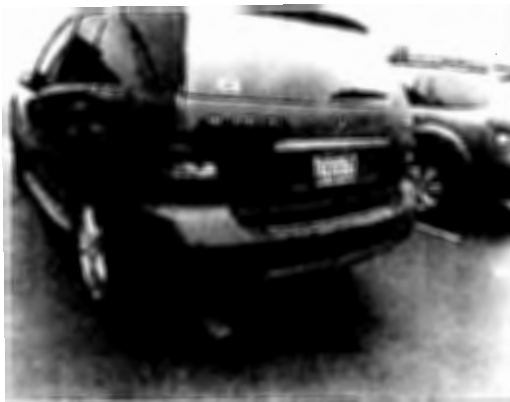
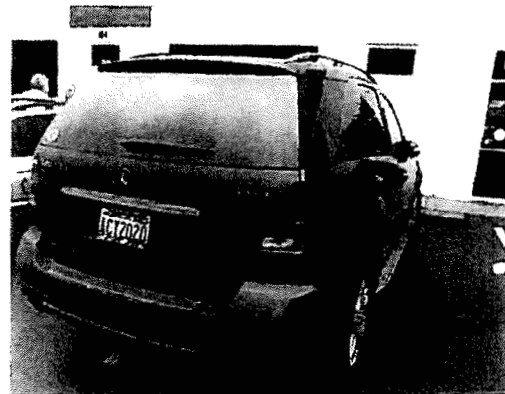
The Estimate of Record for the subject 2007 Mercedes Benz ML320 reported damage to the rear bumper lower cover, molding, lower shield, right muffler and tailpipe, and rear bumper cover, which is consistent with the reviewed photographs (Figure 1). In addition, the repair documents noted prior damage to the front bumper and hood. There was minor displacement of the lower rear bumper, as well as scratches and minor displacement of the right tailpipe. Scratches were also visible on the right side of the rear bumper cover. Ms. Dworsky testified that the subject Mercedes Benz "*was dented and the back panel was pushed in*". Ms. Crum testified that the subject Mercedes Benz had "*no damage*".

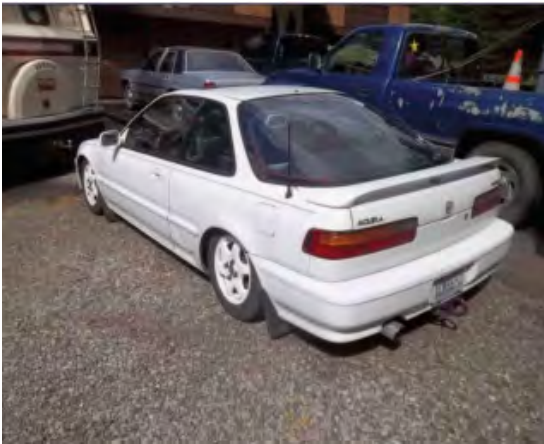
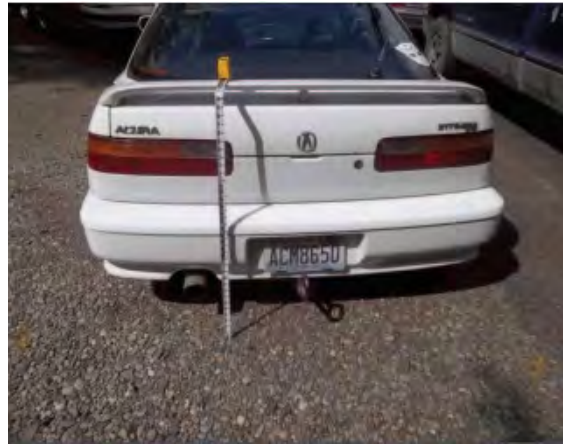
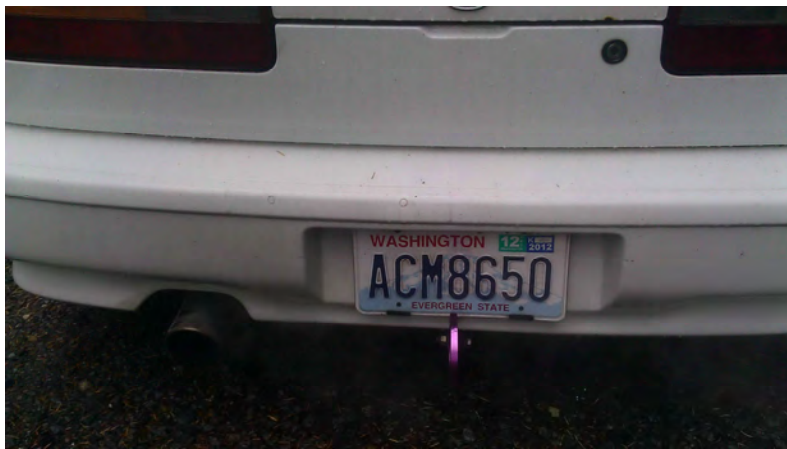
**Figure 1: Reproductions of photographs of the subject 1993 Acura Integra**

Energy-based crush analyses have been shown to represent valid and accurate methods for determining the severity of automobile collisions.<sup>13,14,15,16,17</sup> Analyses of the photograph and geometric measurements along with the repair record of the subject 1993 Acura Integra revealed the damage due to the subject incident. An energy crush analysis<sup>18,19</sup> indicates that a single 10 mile per hour flat barrier impact to the rear of an Acura Integra of the same production year would result in significant and visibly noticeable crush across the entirety of the subject Integra's rear structure, with a residual crush of 3.5 inches. Therefore, the energy crush analysis shows significantly greater deformation would occur in a 10 mile per hour Delta-V (the Delta-V is the change in velocity of the vehicle from its pre-impact, initial velocity, to its post-impact velocity) impact than that of the subject incident.<sup>20</sup> The lack of significant structural crush to the entire rear of the subject Acura Integra indicates a collision resulting in a Delta-V significantly below 10 miles per hour. These results are consistent with an energy-based crush analysis to the front of a 2012 Mazda 3.

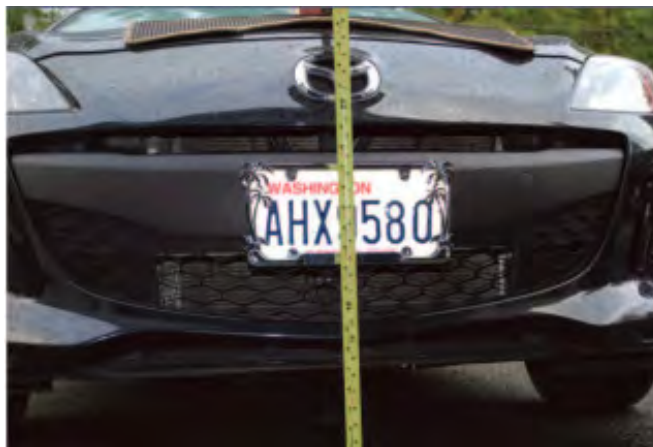
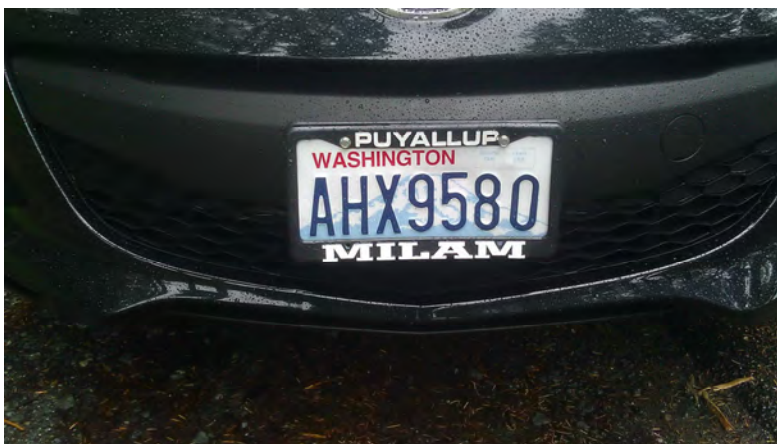
**Figure 2: Reproductions of photographs of the incident 2012 Acura Integra**

The Estimate of Repair for the incident 2012 Mazda 3 indicated damage to the front bumper cover, and noted unrelated dents and scratches. The photographs depicted a minor ding to the right of the lower bumper cover beneath the grille (Figure 2). There was no significant residual crush to the front of the vehicle, and the bumper cover was well aligned with the hood and headlights.

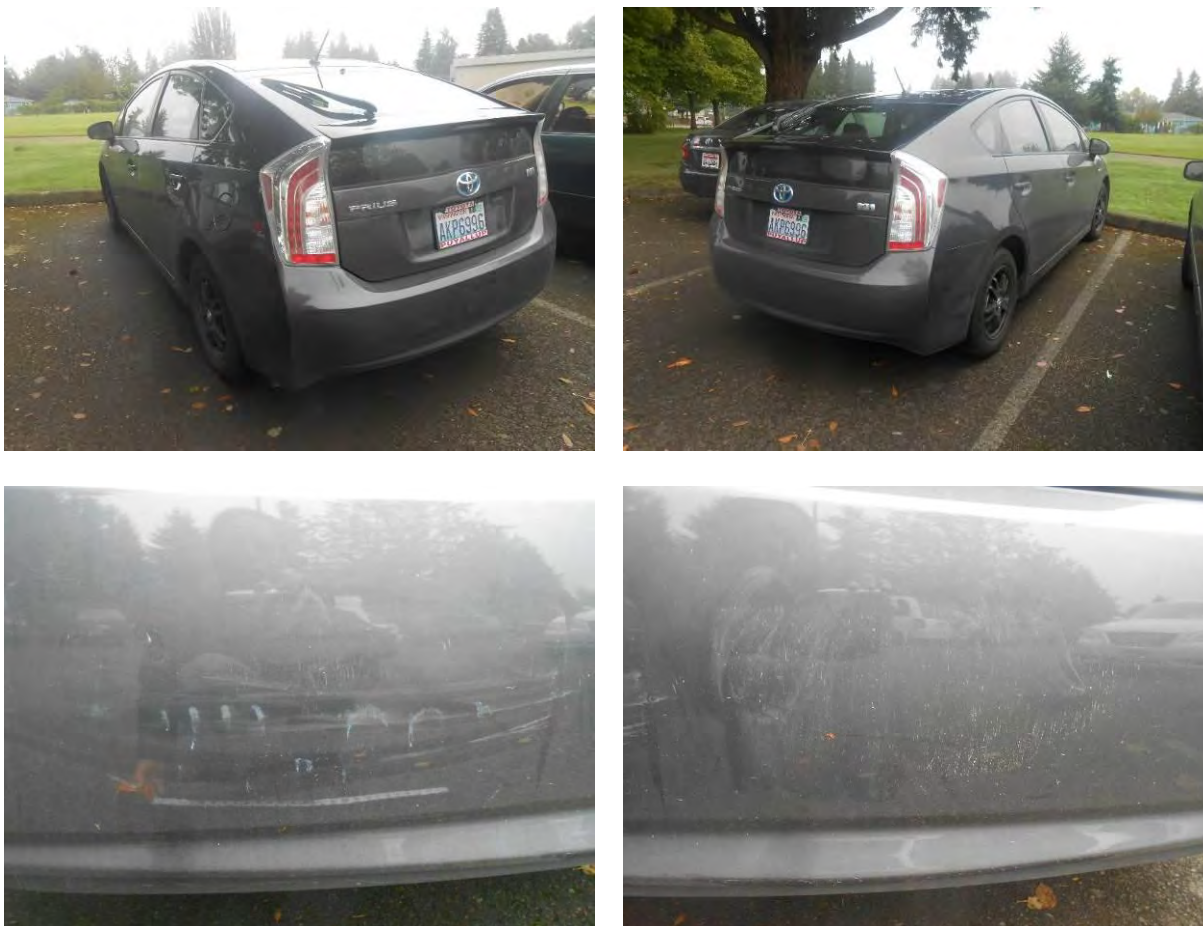
**Figure 1: Reproductions of photographs of the subject 2013 Toyota Prius**

(Figure 1). Overall, the photographs did not depict significant crush or misalignment of the rear components on the Toyota Prius.

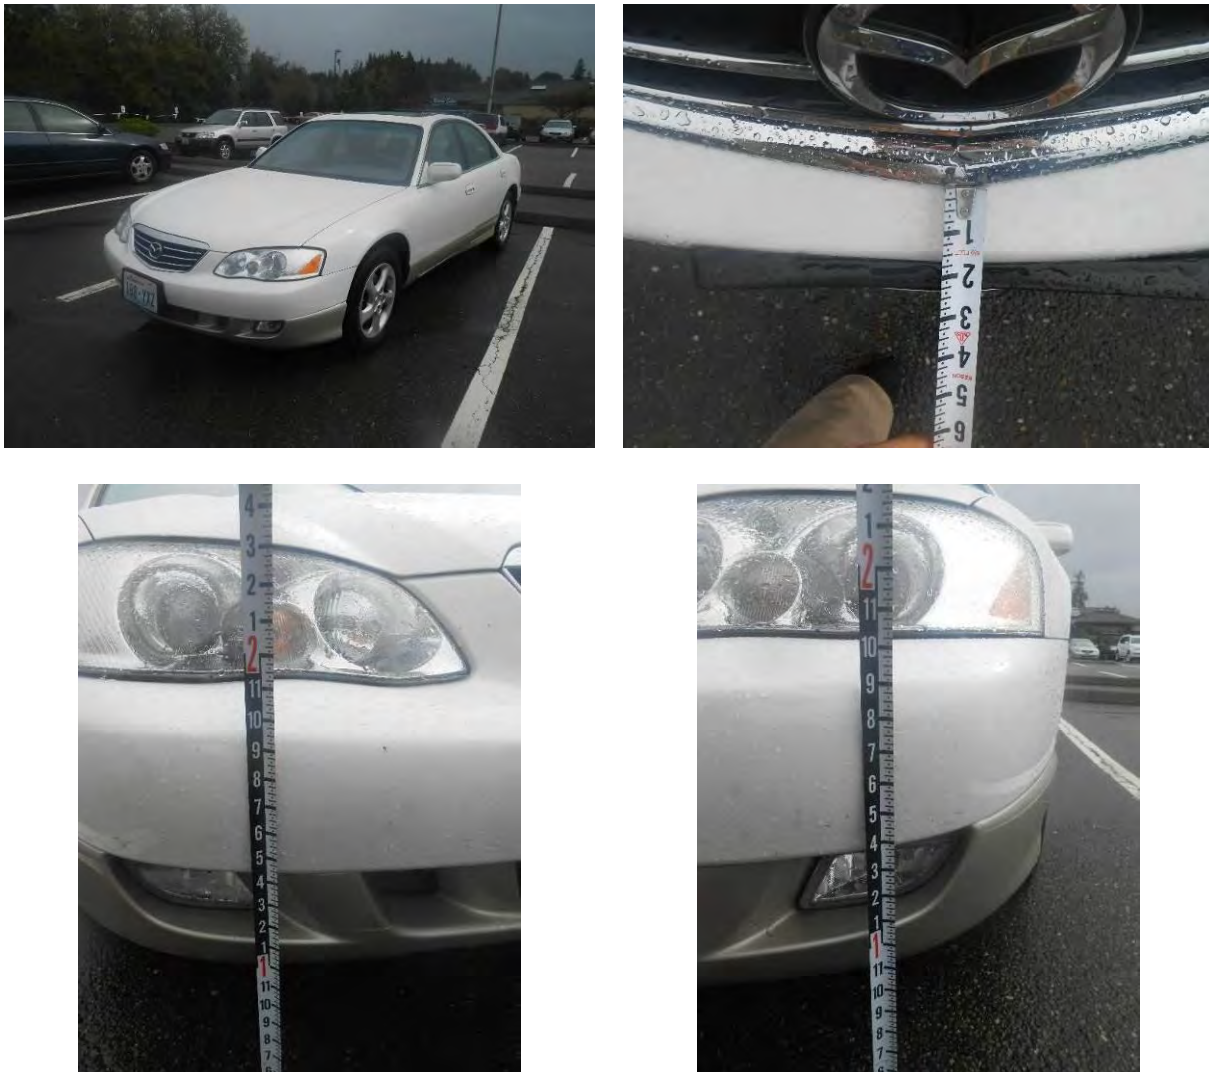
**Figure 2: Reproductions of photographs of the incident 2002 Mazda Millenia**

The repair documents for the incident Mazda Millenia reported no damage due to the subject incident. The reviewed photographs of the incident Mazda depicted no visible damage (Figure 2). The front bumper cover, license plate, license bracket, headlamps, grille, and hood all remained in proper alignment. Further, there was not significant crush or indentation to the front of the incident Mazda.

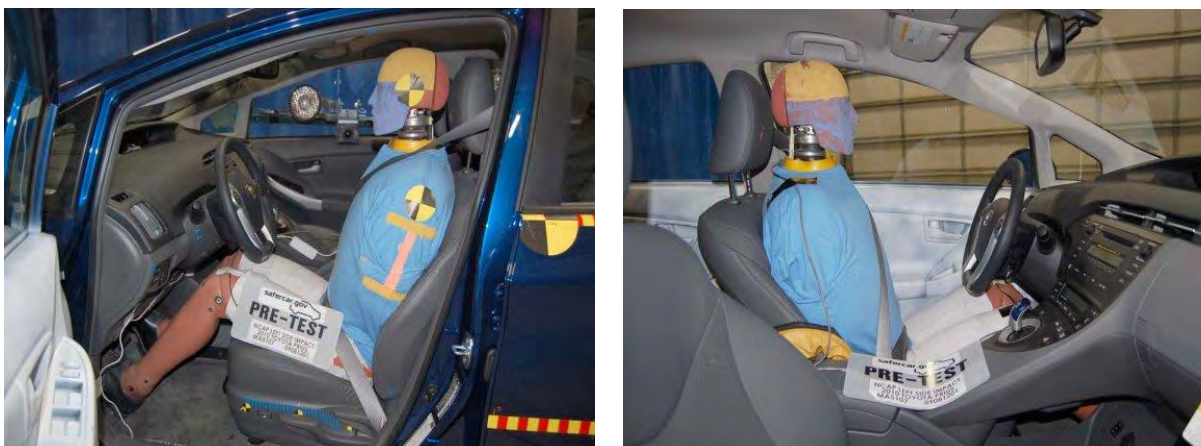
rearward relative to the vehicle, until his motion was stopped by the seatback and seat bottom. The National Highway Traffic Safety Administration (NHTSA) performs impact safety tests for continued performance and safety monitoring of the automotive industry. Tests for a 2010-2015 model Toyota Prius showed the seated height of a 50<sup>th</sup> percentile male in the driver's seat was well protected and supported by the head restraint (Figure 3).<sup>24,25</sup>

**Figure 3: 50<sup>th</sup> Percentile Male Anthropomorphic Test Device**

Performing an anthropometric regression of Mr. Whitaker revealed he would have a normal seated height of 36.3 inches, while a 50<sup>th</sup> percentile male has a seated height approximately 1.5 inches shorter. As such, Mr. Whitaker's head and cervical spine would be well supported.<sup>26</sup> The seatback and headrest support and the low vehicle accelerations during the subject incident designate that Mr. Whitaker's cervical spine would have undergone only a subtle degree of the characteristic response phases.<sup>27</sup> The load would have been applied predominantly horizontal to his cervical spine and minimized relevant cervical loads.<sup>28</sup> The available documents indicated Mr. Whitaker did not strike his head. Studies by West showed that head contact did not occur at a Delta-V below 3.3 mph.<sup>29</sup> The cervical loads were within physiologic limits and Mr. Whitaker would not have been exposed to a cervical spine biomechanical failure mechanism during the subject incident.<sup>30,31,32</sup>

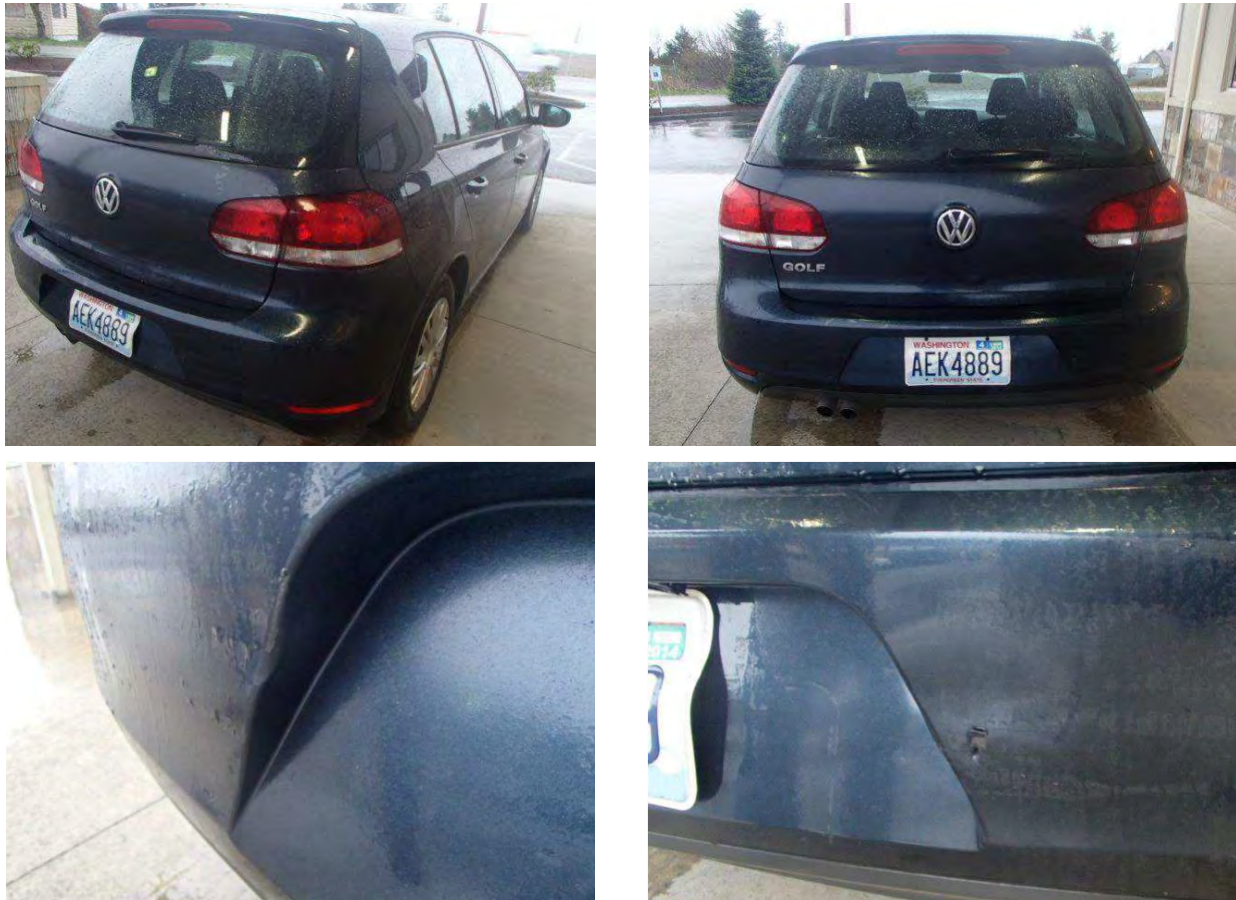
**Figure 1: Reproductions of photographs of the subject 2011 Volkswagen Golf**

to the rear of the vehicle other than the license plate. According to the Shoreline Fire Department incident report, there was “*minimal damage/scratch on bumper*” on the subject Volkswagen.

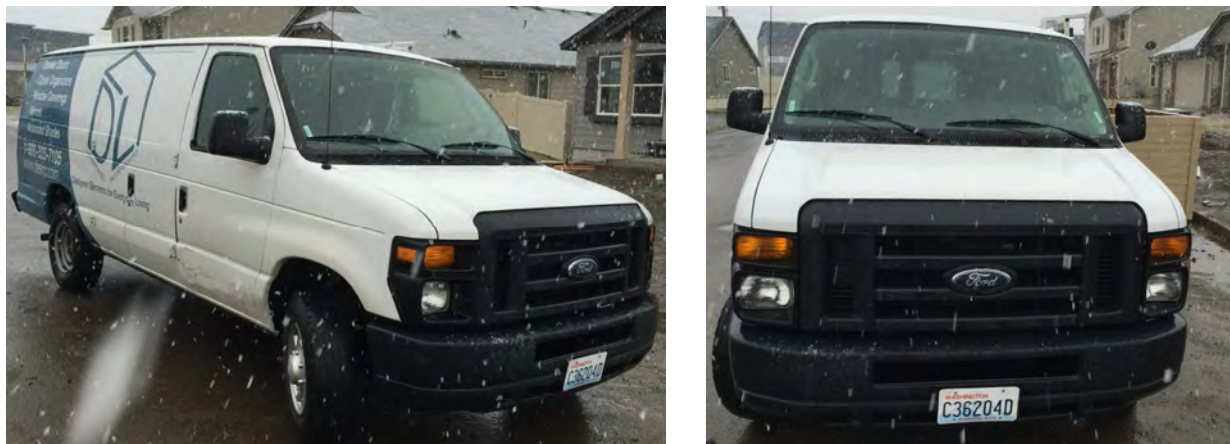
The photographs of the incident 2013 Ford E250 Van depicted no residual damage (Figure 2). There were scuffs to the front bumper indicative of contact to the left and right sides of the upper portion of on the front bumper. However, the license plate was not bent, and the bumper was in alignment with the grille, head lights, fenders, and hood.

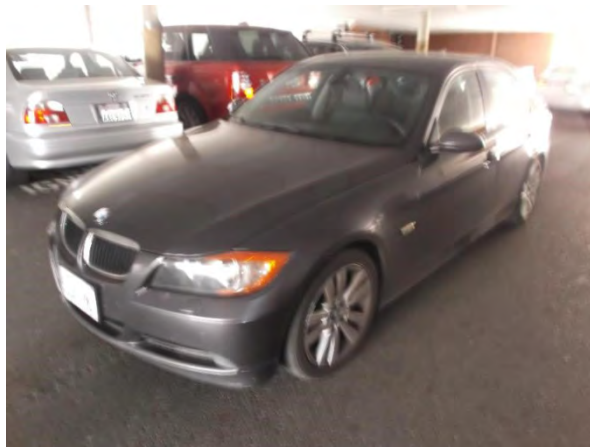
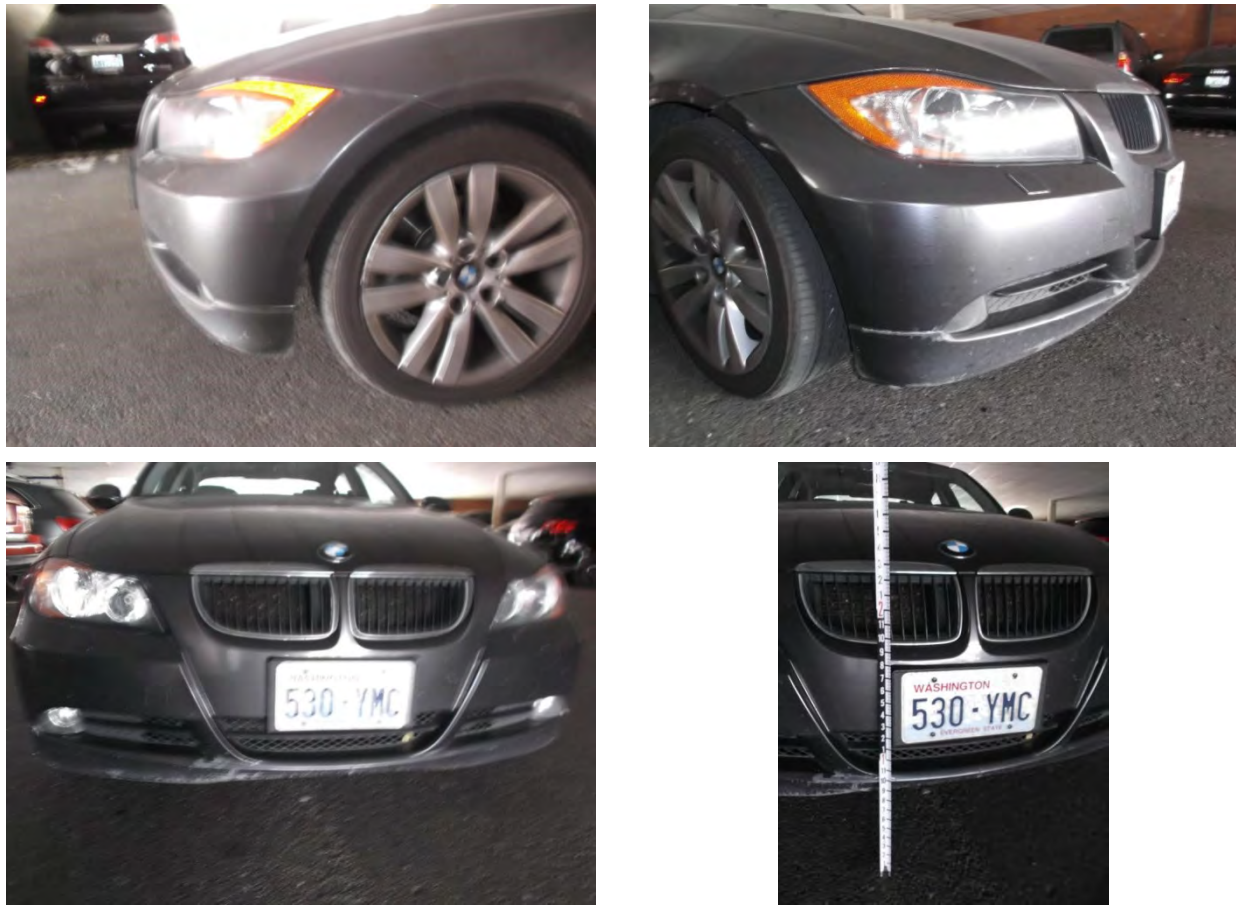
**Figure 2: Reproductions of photographs of the incident 2006 BMW 325i**

The photographs for the incident 2006 BMW 325i depicted no residual crush or signs of structural damage (Figure 2). The front bumper was well aligned with the head lights, grille, hood, and front fenders. There were minor chips and paint scratches to the right side of the front bumper cover.

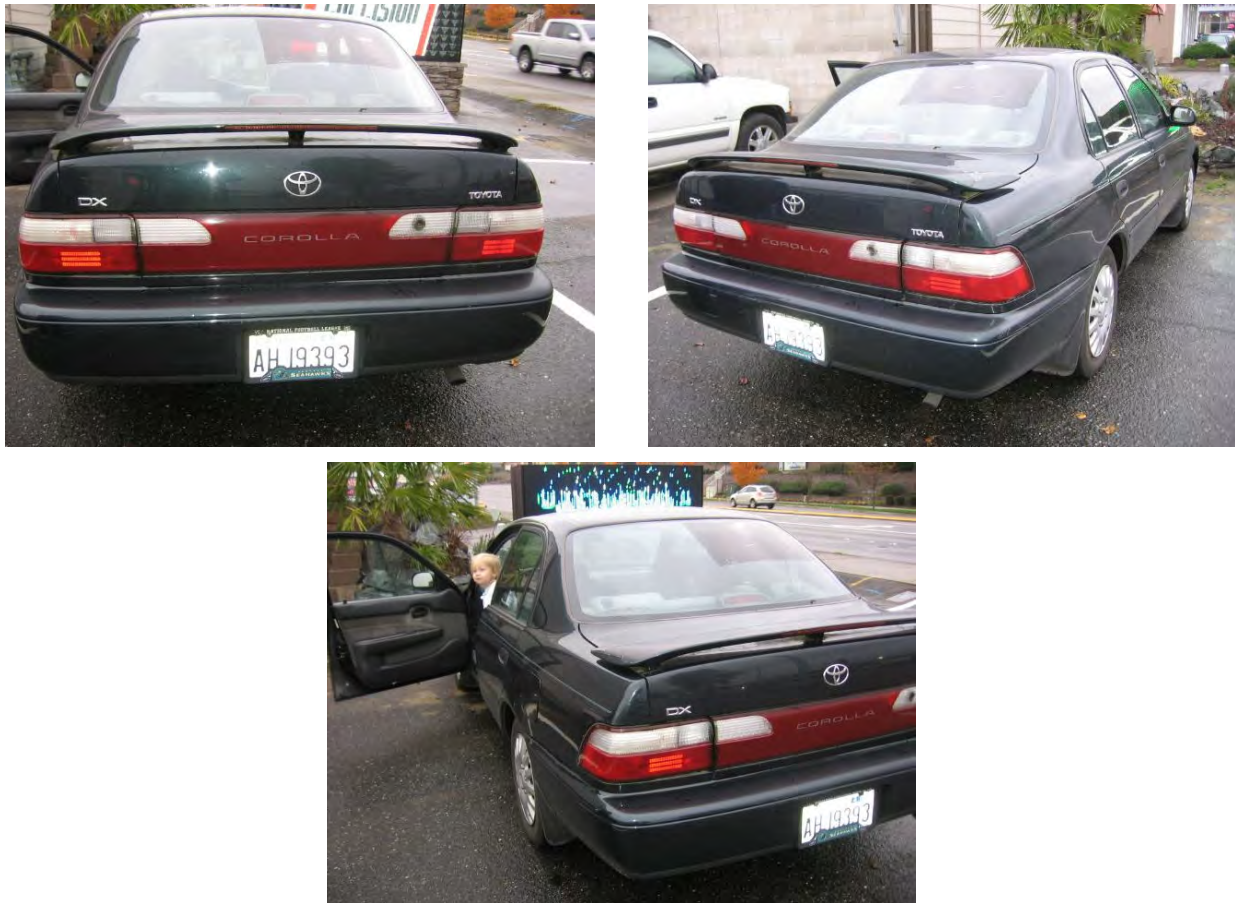
**Figure 1: Reproductions of photographs of the subject 1996 Toyota Corolla**

Energy-based crush analyses have been shown to represent valid and accurate methods for determining the severity of automobile collisions.<sup>13,14,15,16,17</sup> Analyses of the photograph and geometric measurements, along with the repair record of the subject 1996 Toyota Corolla revealed the damage due to the subject incident. An energy crush analysis<sup>18,19</sup> indicates that a single 10 mile per hour flat barrier impact to the rear of a 1996 Toyota Corolla would result in significant and visibly noticeable crush across the entirety of the subject Corolla's rear structure, with a residual crush of 4.75 inches. Therefore, the energy crush analysis shows significantly greater deformation would occur in a 10 mile per hour Delta-V (the Delta-V is the change in velocity of the vehicle from its pre-impact, initial velocity, to its post-impact velocity) impact than that of the subject incident.<sup>20</sup> The lack of significant structural crush to the entire front of the subject Toyota Corolla indicates a collision resulting in a Delta-V significantly below 10 miles per hour.

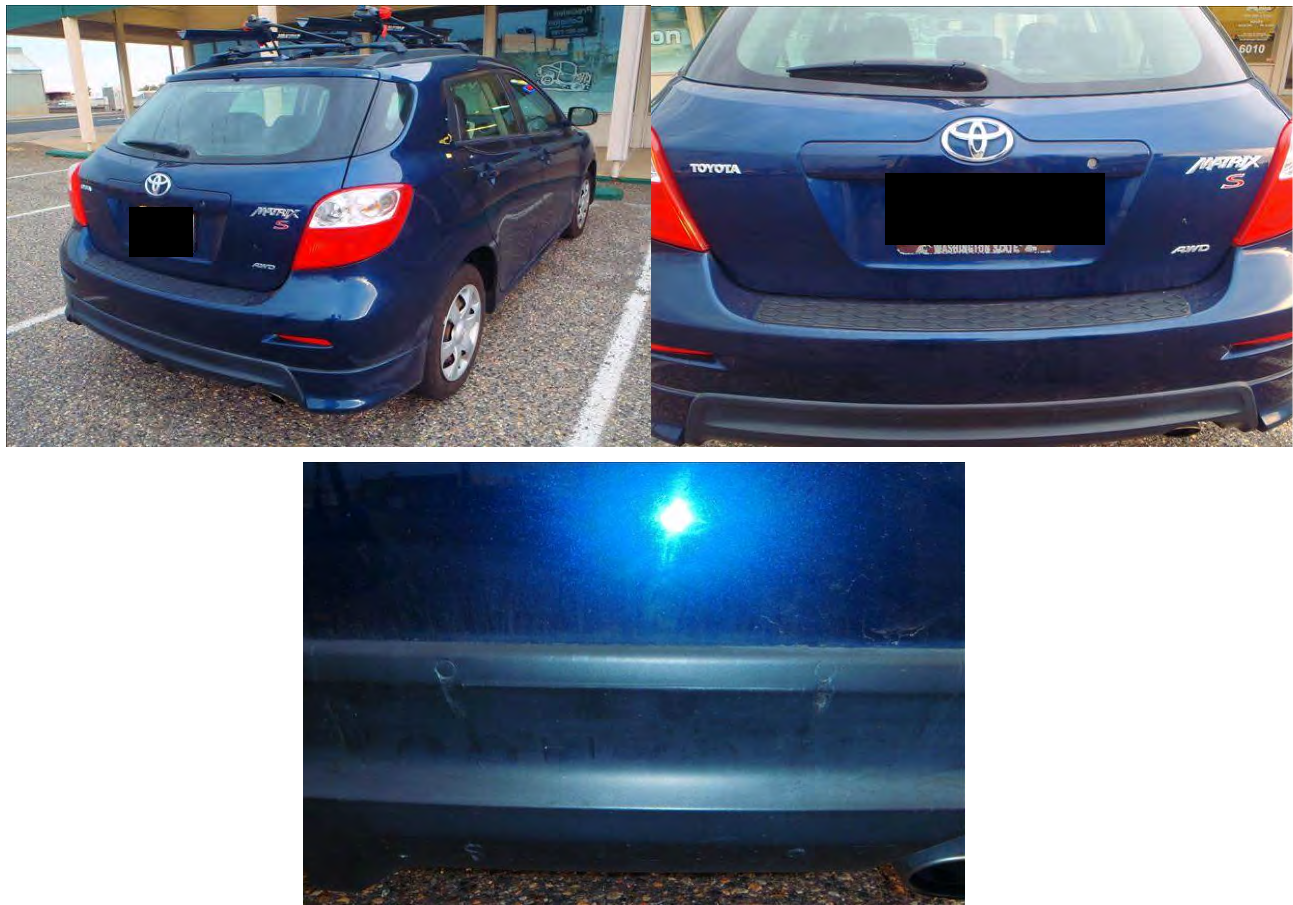
**Figure 1: Reproductions of photographs of the subject 2009 Toyota Matrix**

Energy-based crush analyses have been shown to represent valid and accurate methods for determining the severity of automobile collisions.<sup>13,14,15,16,17</sup> Analyses of the photograph and geometric measurements along with the repair record of the subject 2009 Toyota Matrix revealed the damage due to the subject incident. An energy crush analysis<sup>18,19</sup> indicates that a single 10 mile per hour flat barrier impact to the rear of a 2009 Toyota Matrix would result in significant and visibly noticeable crush across the entirety of the subject Matrix's rear structure, with a residual crush of 3 inches. Therefore, the energy crush analysis shows significantly greater deformation would occur in a 10 mile per hour Delta-V (the Delta-V is the change in velocity of the vehicle from its pre-impact, initial velocity, to its post-impact velocity) impact than that of the subject incident.<sup>20</sup>

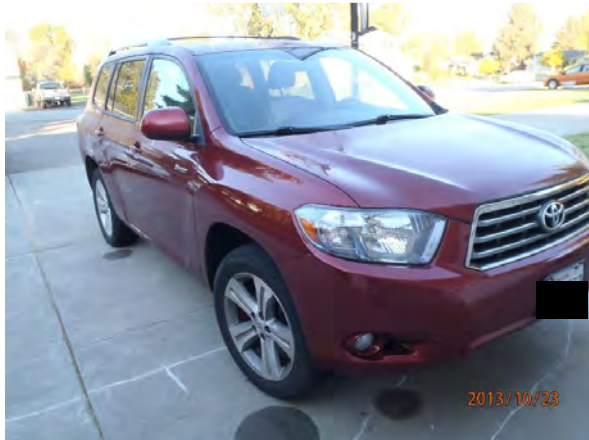
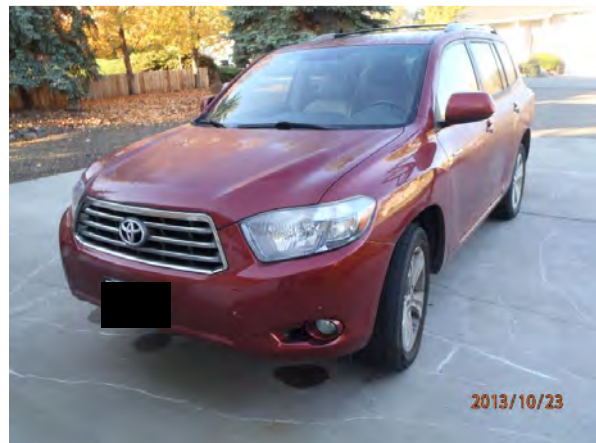
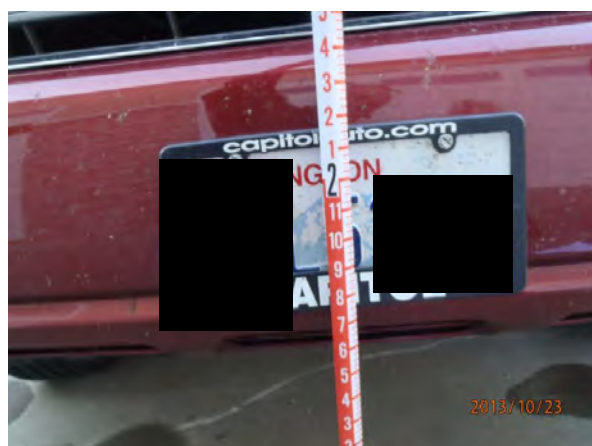
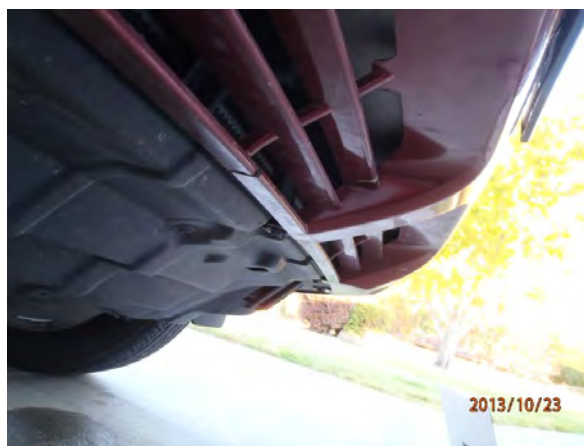
**Figure 2: Reproductions of photographs of the incident 2008 Toyota Highlander**

The repair documents for the incident 2008 Toyota Highlander indicated there was no damage related to the subject incident. The repair documents did note prior damage to the left corner of the front bumper cover, and a crack to the center of the lower grille. The photographs depicted the crack to the lower grille, which was recessed from the front bumper cover (Figure 2). The front bumper cover was in alignment with the head lamps, upper grille, fenders, and hood.

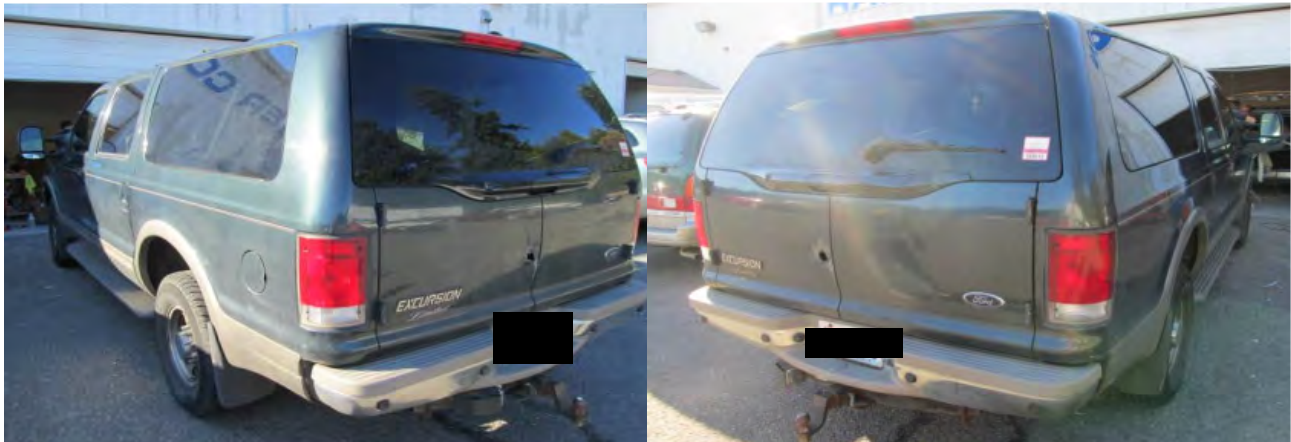
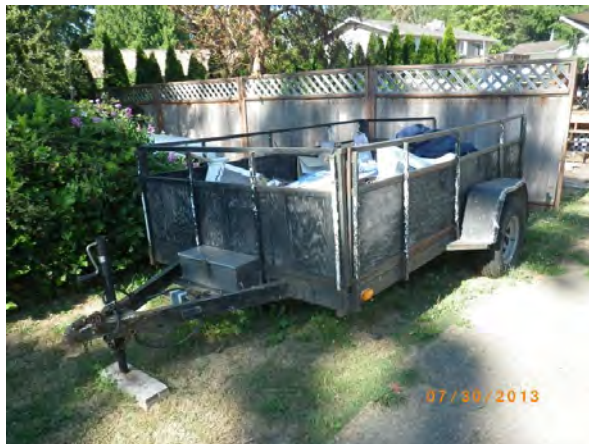
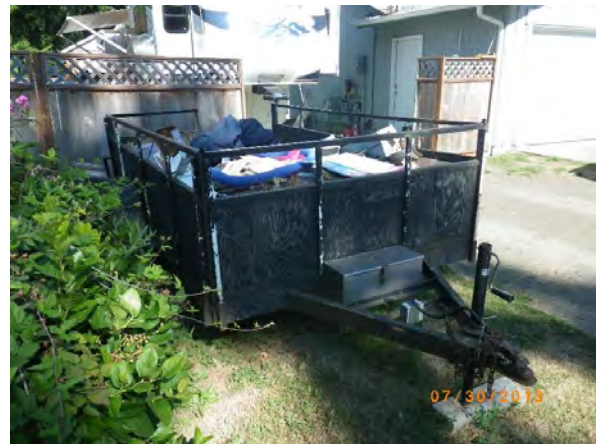
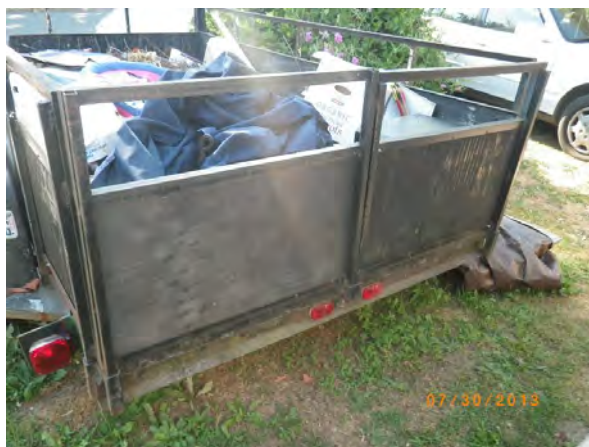
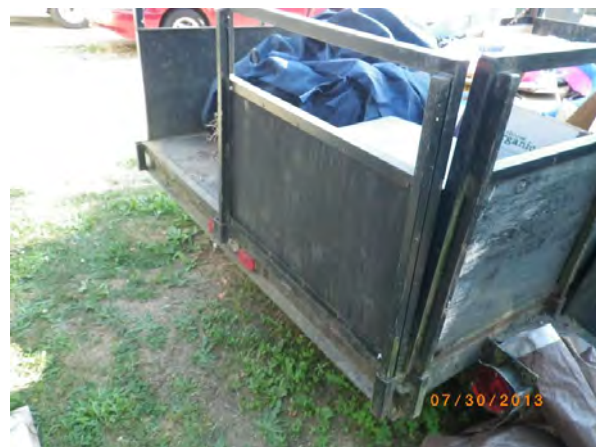
**Figure 1: Reproductions of photographs of the subject 2001 Ford Excursion and trailer.**

The repair estimate for the subject 2001 Ford Excursion reported only pre-existing damage, consisting of damage to the left and right back door assemblies (Figure 1). In her testimony, [REDACTED] testified there was no damage to the subject vehicle, but noted damage to the trailer, “*a little bend on the rear gate frame in the metal*”. The photographs of the subject Excursion depicted no residual crush to the rear bumper. A hole in the left back door, noted as pre-existing, was visible. There was no significant crush to the rear of the subject trailer, and no indication of significant deformation to the trailer hitch or vehicle receiver. The records indicate the trailer was loaded with wood, a riding lawn mower, and a gasoline tank. [REDACTED] testified the lawn mower moved as a result of the subject incident, but the wood did not.

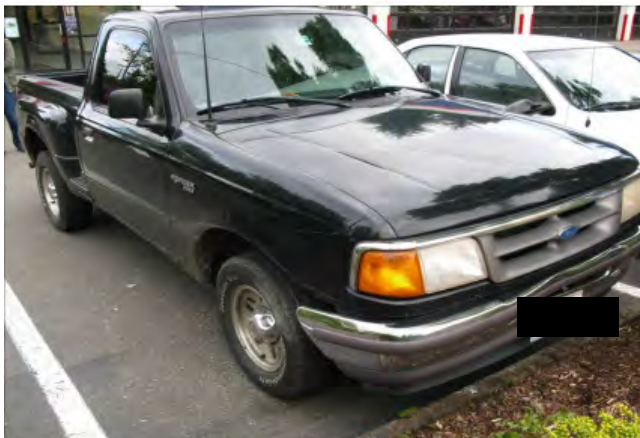
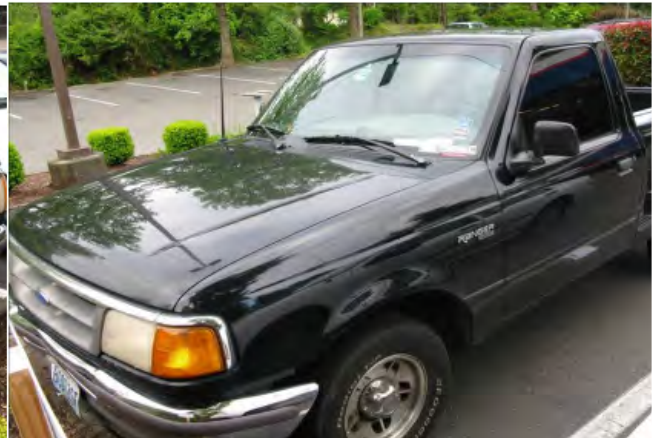
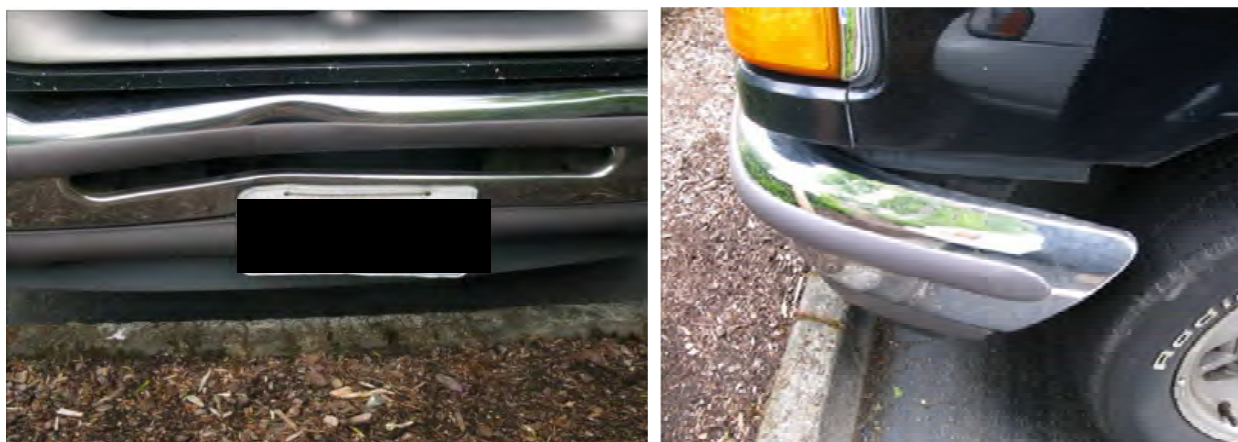
**Figure 2: Reproductions of photographs of the incident 1996 Ford Ranger**

The repair documents for the incident 1996 Ford Ranger indicated there was damage to the front bumper, right and left bumper bracket, and valence panel (Figure 2). Prior damage was also noted as there were dents to the front end and tailgate, and scratches throughout the right side. The photographs depicted some crush to the center of the front bumper, which was also partially displaced.

testified that the front bumper of the incident Ranger “looked like it was buckled in a little bit”.

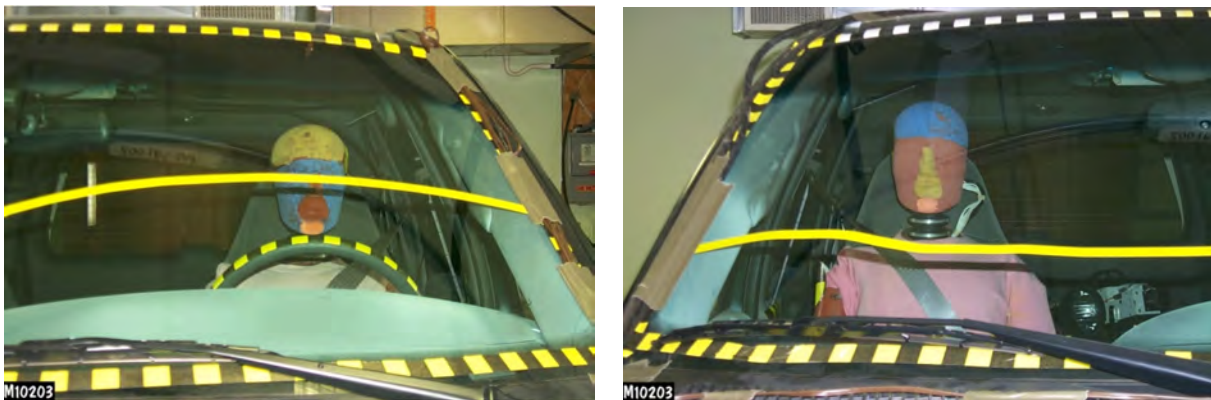
There is no reason to assume that the claimed cervical biomechanical failures are causally related to the subject incident. In a rear impact that produces motion of the subject vehicle, the Ford Excursion would be pushed forward and [REDACTED] would have moved rearward relative to the vehicle, until their motion was stopped by the seatback and seat bottom. The National Highway Traffic Safety Administration (NHTSA) conducts impact safety tests for continued performance and safety monitoring of the automotive industry. Testing for an exemplar 2001 Ford Excursion showed the seated height of a 50<sup>th</sup> percentile male in the driver and passenger seat was well protected and supported by the seatback components (Figure 3).<sup>37</sup>

**Figure 3: NHTSA 50<sup>th</sup> percentile male in driver and front passenger seats.**
